FINAL REPORT NUMBER 201U-MGA-04-06

SAFETY COMPLIANCE TESTING FOR FMVSS 201U
Occupant Protection In Interior Impact
Upper Interior Head Impact Protection

LAND ROVER IN THE UK
2004 LAND ROVER FREELANDER SE MPV
NHTSA No. C40602

MGA RESEARCH CORPORATION
446 Executive Drive
Troy, Michigan 48083

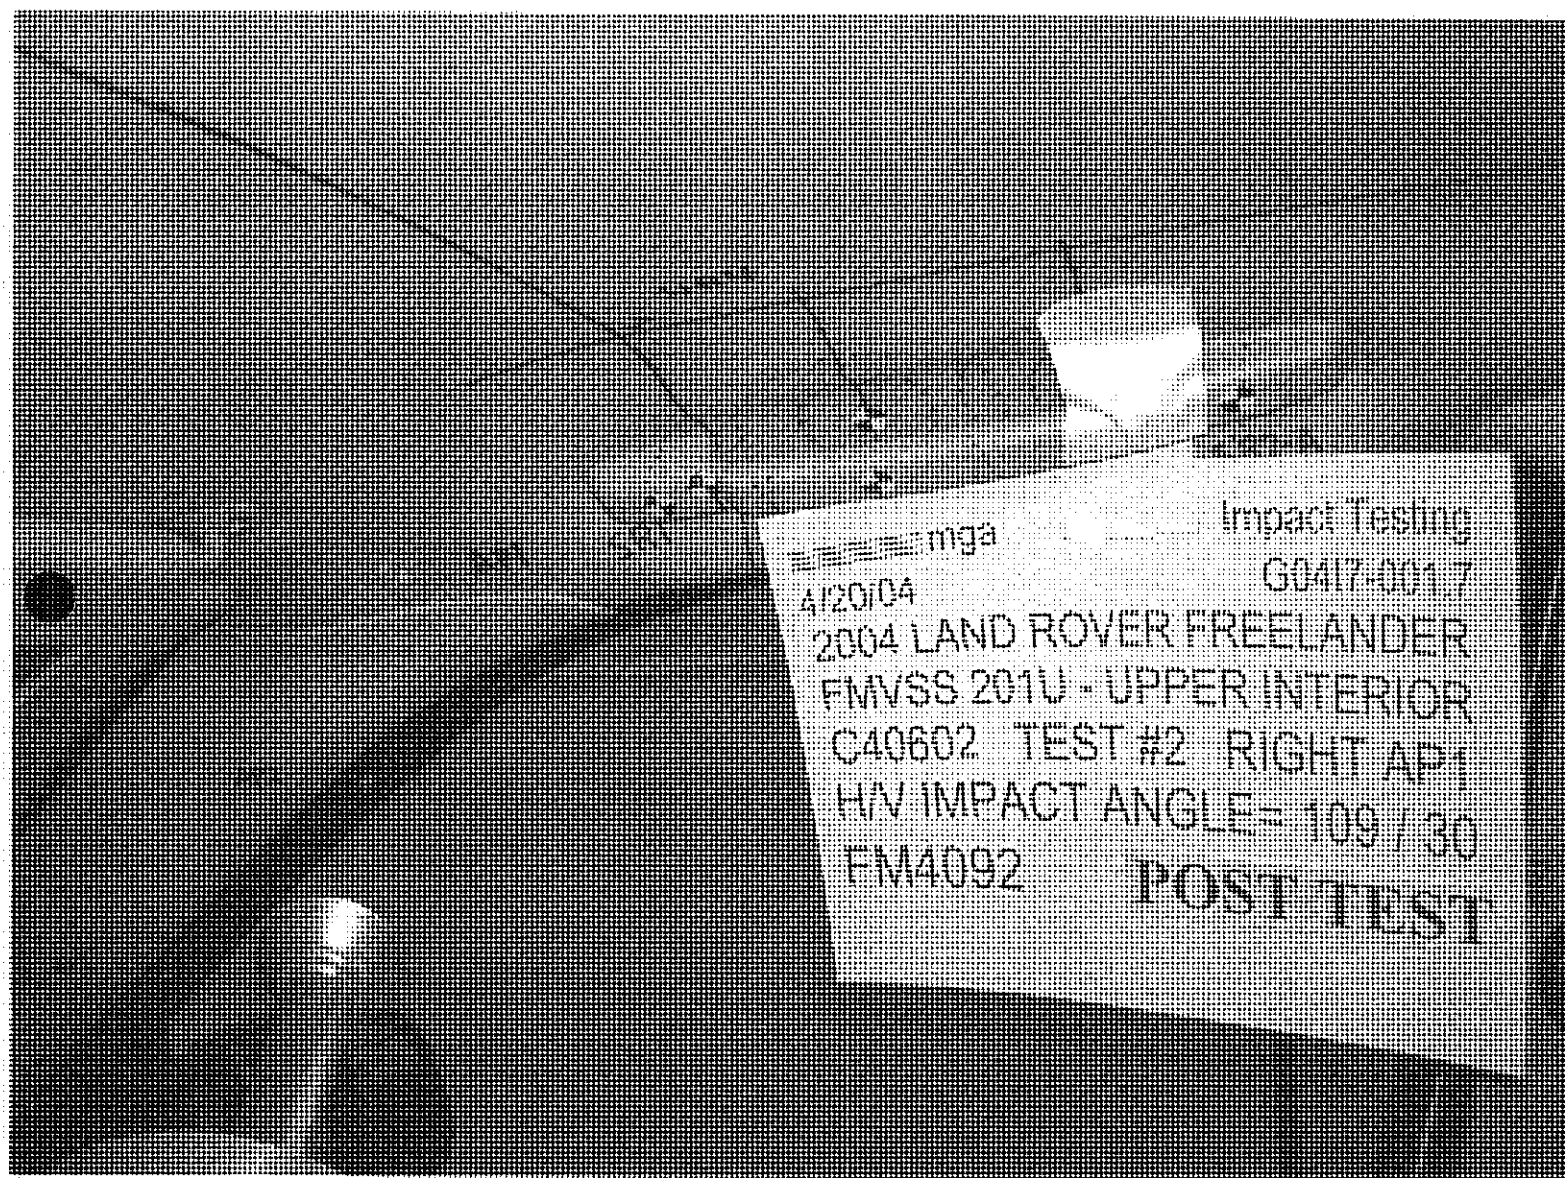
Impact Testing
G0417-001.7
4/20/04
2004 LAND ROVER FREELANDER
FMVSS 201U - UPPER INTERIOR
C40602 TEST #2 RIGHT AP1
HV IMPACT ANGLE = 109 / 30
FM4092 POST TEST

no visible damage

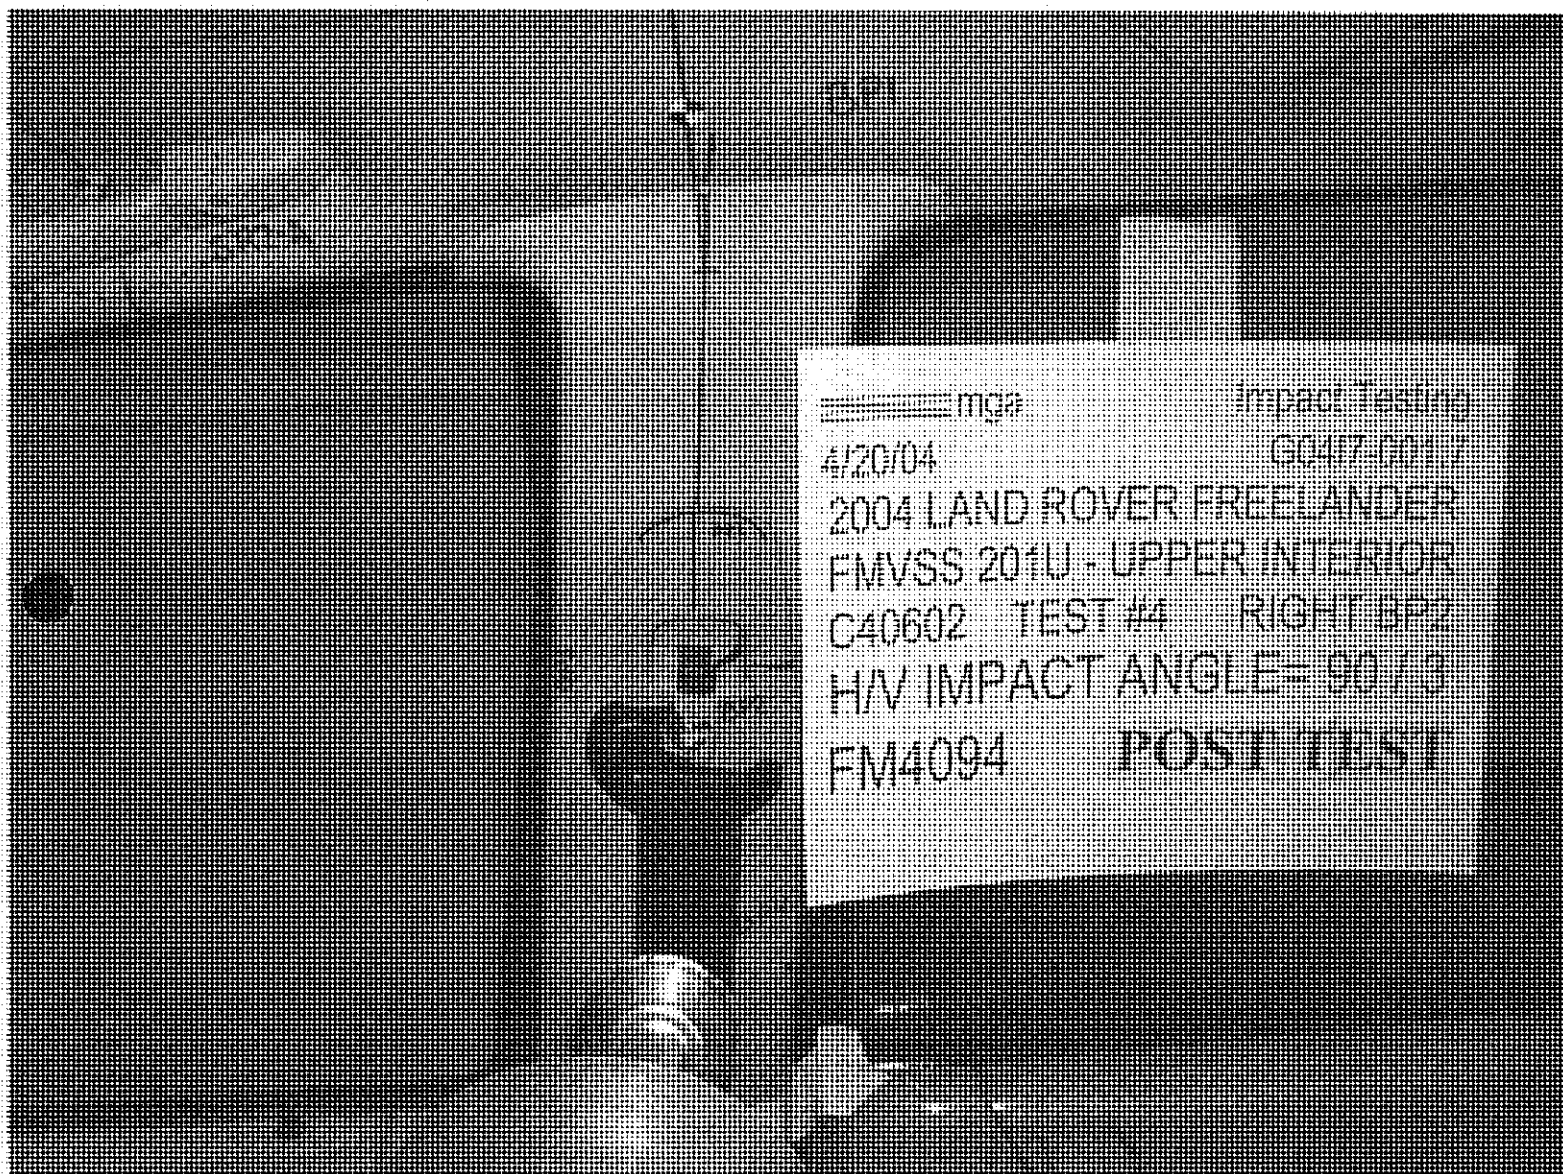
mga Impact Testing
4/20/04 G0417-001.7
2004 LAND ROVER FREELANDER
FMVSS 201U - UPPER INTERIOR
C40602 TEST #4 RIGHT BP2
H/V IMPACT ANGLE= 90 / 3
FM4094 PRE - TEST

BP2 Right: The seat belt anchorage cover was cracked during impact.

SEAT BELT ANCHORAGE COVER WAS CRACKED DURING IMPACT
